EVALUATION OF THE SPRAY ICE BARRIER AT THE CIDS ANTARES SITE DURING 1985 USING TIMELAPSE PHOTOGRAPHY

FINAL REPORT February 1988

POLAR ALPINE, INC.

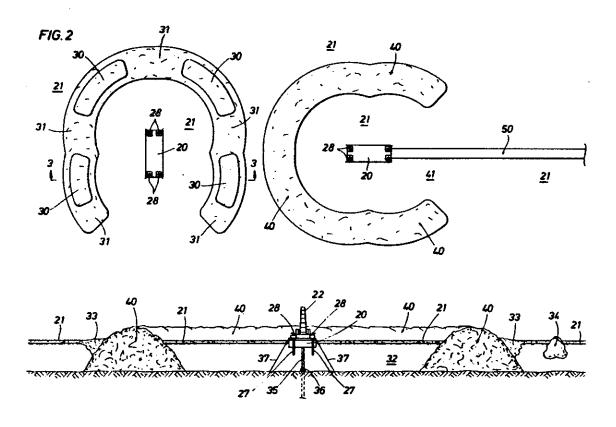
Figure 2, which is also reproduced from the Finucane and Jahns patent, shows a profile view with a cross-section of a spray ice barrier. The cross-section in this diagram may be the inventors' concept of what a cross-section would look like. It should be noted that the subsea profile of the spray ice barrier presented by Finucane and Jahns in Figure 2 is not in static equilibrium.

Figure 2. A cross-section of the spray ice barrier shown in Figure 1. Note the subsea profile presented here. Figure taken from U.S. Patent 4,523,879.

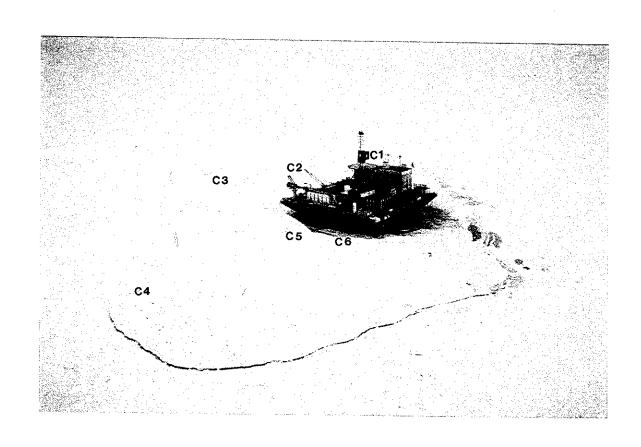
Photograph 2. Aerial view of CIDS and the spray ice barrier looking toward the east. Note the large rubble pile on the northwest side and the section of barrier that was sheared off. Cameras locations are indicated by identifiers Cl-C6.

Photograph 2 is an aerial photograph of the CIDS and the spray ice barrier. In this photograph the spray ice barrier is defined by the smooth snow adjacent to the CIDS. The rougher buildup of ice lying outside the barrier is a rubble pile that formed on the northwest side of the barrier. The horseshoe shape of the barrier can also be observed. To provide the scaling for this photograph, the length across diagonal corners of the CIDS is approximately 400 feet.

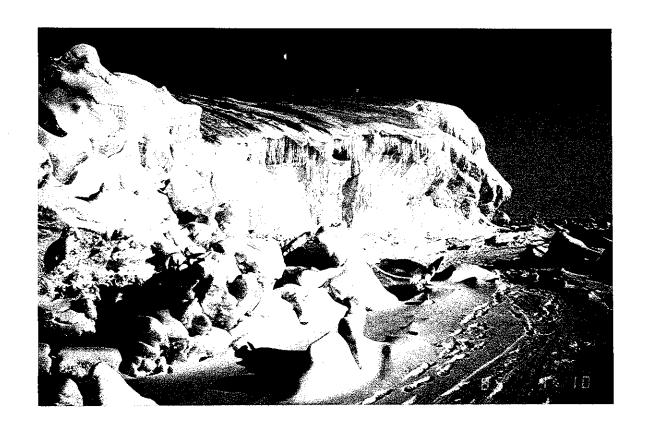
Photograph 6 shows the southwest end of the barrier where a portion of it was sheared off. The camera visible on top of the barrier is 55 feet above sea level. The higher ice at the left of the photograph is the start of the ice rubble pile.

We do not have access to the subsurface profiles of the spray ice barrier so it is difficult to be precise in trying to define why the barrier failed. Spray ice is relatively low density (between 600 and 850 kilograms per cubic meter) and the sintering between the ice grains is generally low. Considering this we would expect that the tensile and shear strength of the material would be low.

Photograph 6. A view at sea level of the sheared-off section of the barrier and part of the ice rubble pile on the northwest side.

We hypothesize that the area of the barrier that failed was not grounded. When the ice movement started the spray ice fractured and the south portion was carried away with the continuing ice movement. Most likely the barrier fractured at a point beyond where it was grounded.

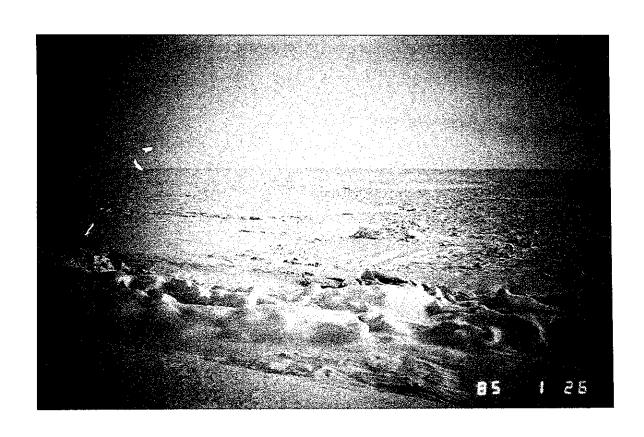
Photograph 7. A view of the low-relief rubble that formed on the east side of the barrier. The build up on the east was not as extensive as that on the northwest.
